## HARRIS COUNTY MUNICIPAL UTILITY DISTRICT NO. 500

### Lake 1G Tie Back Wall Repair Update - 2/24/2020

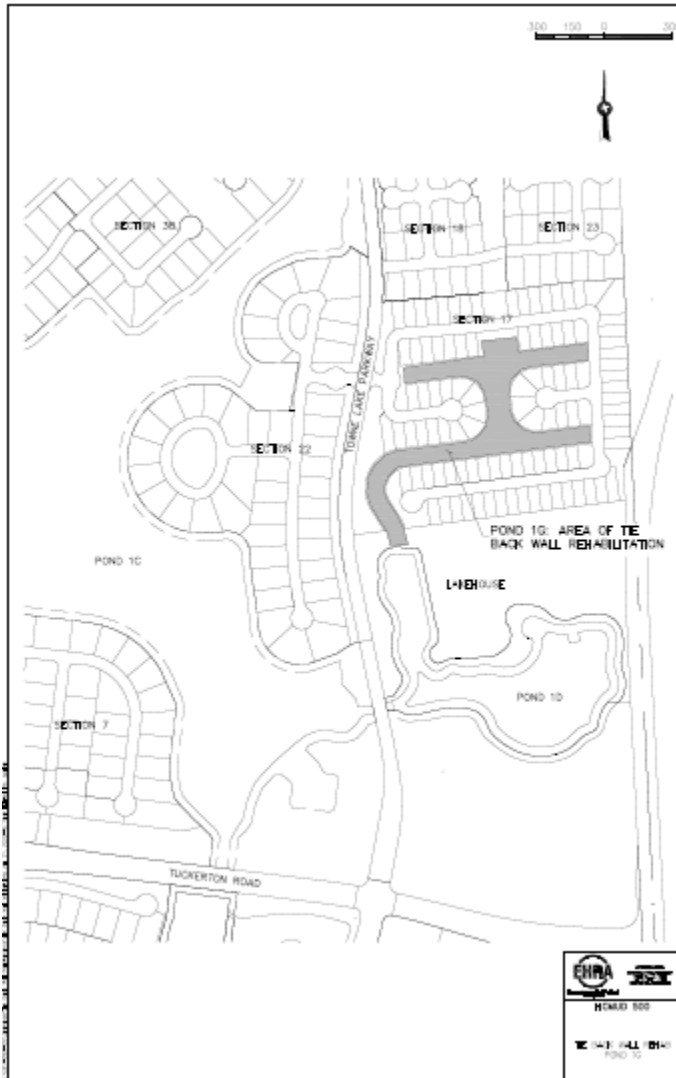
The water in Lake 1G has been pumped out to lower the lake 2' below the normal water elevation. Repairs to static cracks on the tie back walls continue. The repair of the contraction joints has also begun. This involves saw cutting 1" wide into the tie back wall at the crack or existing joint, cleaning the area, and sealing the joint with injection resin and cap paste. As the contraction joints are finished, you will see the sealant (injection resin and cap paste) fill these gaps in the joint. For the corner cracks, repair involves cleaning the cracked area and adding dowels and anchors before repairing the concrete. The project is on schedule to be complete by the end of the contract date of March 28, 2020.
